# Collision

# CRASH BEHAVIOUR IN A CRASH COMPARISON:

## THE NEW BIOFIDELIC DUMMY IN DIFFERENT SCENARIOS OF ACCIDENTS INVOLVING PASSENGER CARS AND PEDESTRIANS

Annika Kortmann

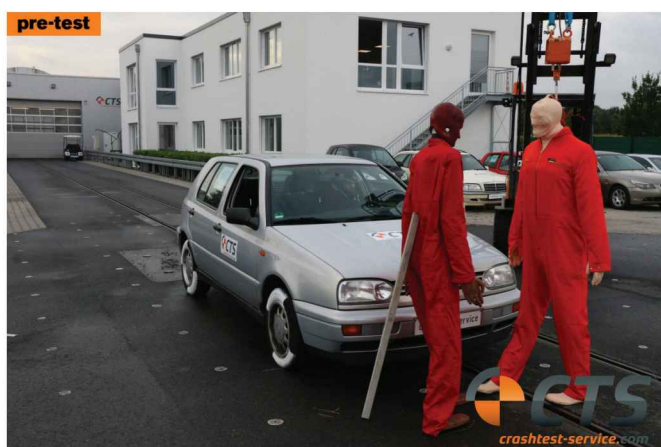
**Figure 3: The impact configuration with a conventional (NAMI-) dummy in vehicle plan view on the left side**

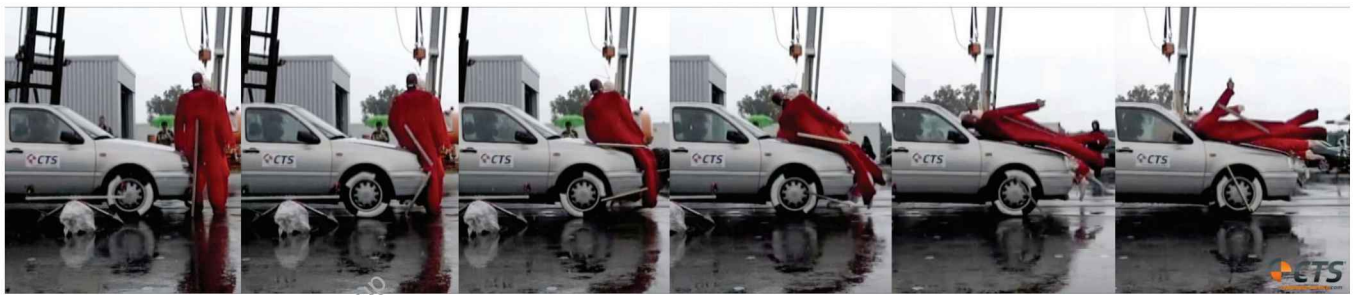
*Figure 4: The movement sequences of the conventional dummy*

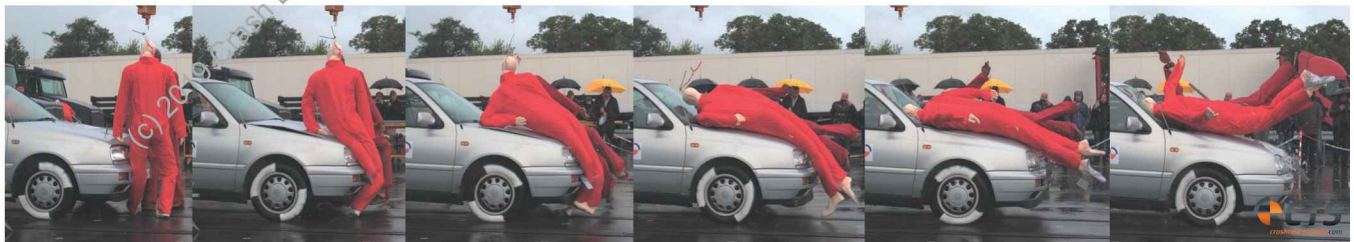
*Figure 5: The movement sequences of the biofidelic dummy impacted by a passenger car (mirrored)*

the course of the collision. The head impact occurs with a movement from the top downwards whilst the body makes contact with the bonnet.

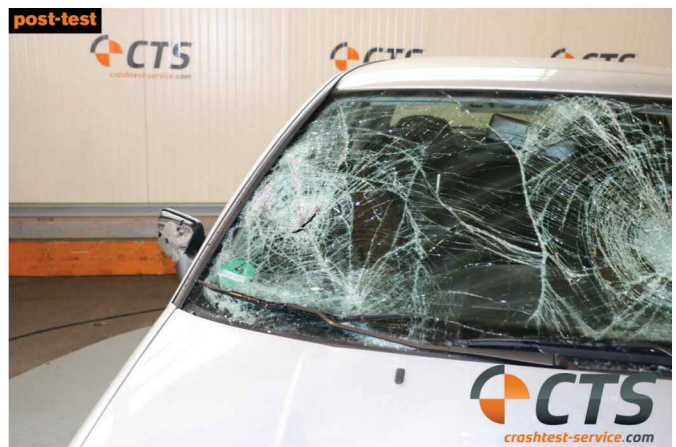
*Figure 7: Fracture pattern in the windscreen*

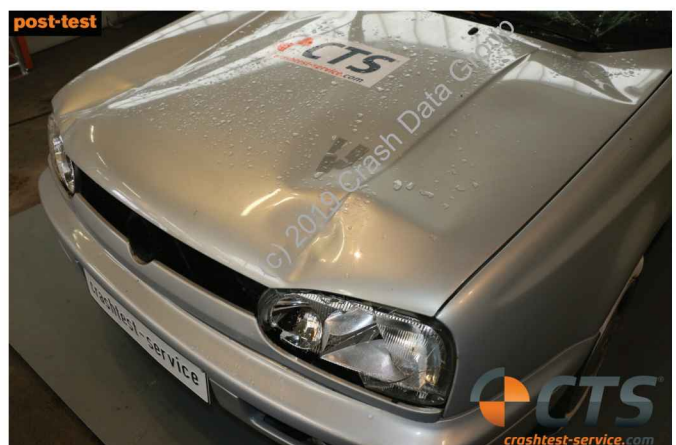
*Figure 8: Damages caused to the bonnet*

in the damages caused to the bonnet, see Figure 8 (right image). During the impact of the NAMI on the car bonnet, the damages caused are extensive and also include several scratches, which would not occur in a real pedestrian accident (Figure 8, left image).

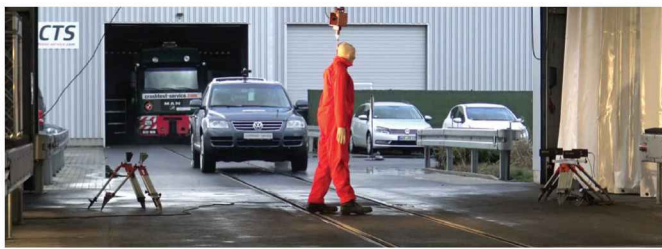
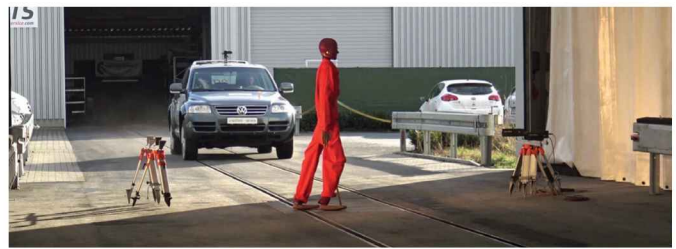
*Figure 9: The test setup, where a biofidelic and a NAMI-dummy under identical conditions are impacted with a VW Touareg*

Figure 9 shows the test setup, where a biofidelic and a NAMI-dummy under identical conditions are impacted with a VW Touareg (Type 7L) at a velocity of just over 40 kph. Also the comparison of the impact configurations shown in Figure 10 validates the identical test setup. By means of the optical comparison of the impact configurations from Figure 3 and Figure 10 it becomes evident, that the lower edge of the bonnet of the VW Touareg around is 25 cm higher than the VW Golf III. In order to determine whether the previous rolling-off and clinging-on behaviour of the biofidelic dummy to the bonnet also takes place with an SUV front, the study of the movement sequences during the collision is of crucial importance.

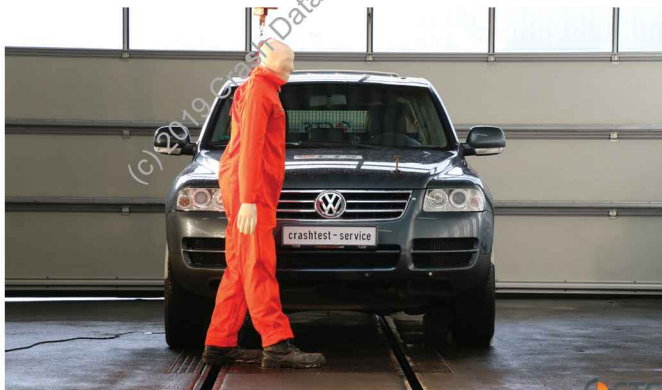
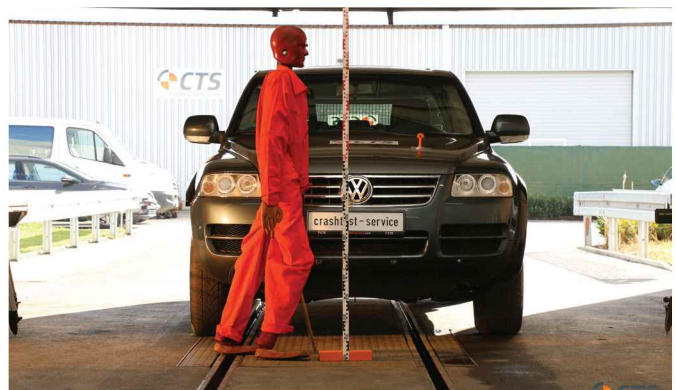
*Figure 10: The test setup, where a biofidelic and a NAMI-dummy under identical conditions are impacted with a VW Touareg*

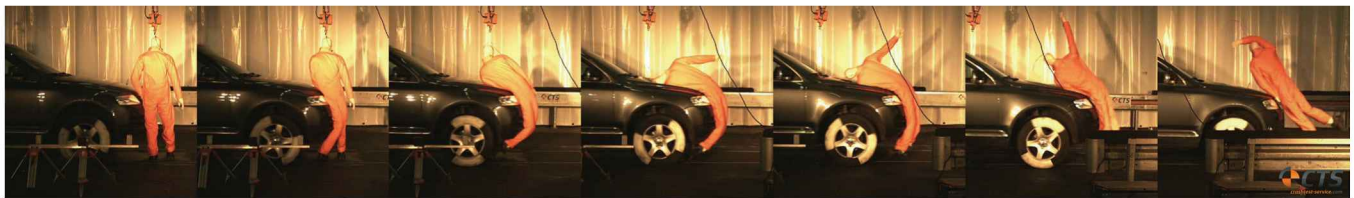
*Figure 11: Movement sequences during the test with the biofidelic dummy*

As also previously in the crash test with the VW Golf III, a high-speed recording was made from the side view taken at the height of the collision, the movement sequences are correspondingly shown in Figure 11 and 12. In Figure 11 it becomes apparent that despite of the higher bonnet, as previously observed, the clinging of the biofidelic dummy on the SUV front and bonnet also takes place. The

typical undergoing of the feet is also present in the crash with this vehicle type. During the course of the collision, the dummy adapts itself with the contour of the vehicle front, whereby the upper body presses from the top on the bonnet and the head impacts the bonnet with such a momentum in a sideways tilting movement. After the main exchange of force the movement of the dummy is opposed and it is then thrown off forwards in the SUV's direction of travel.

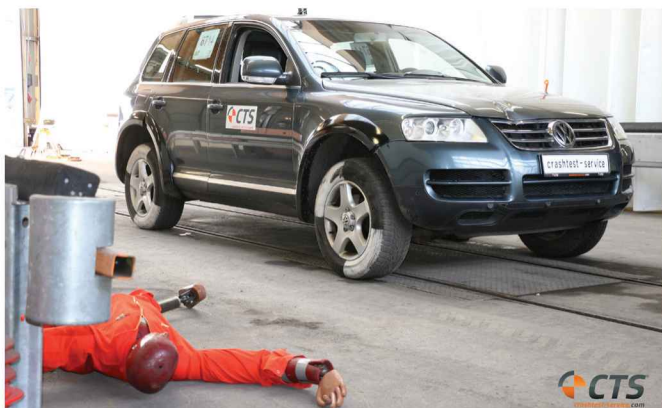
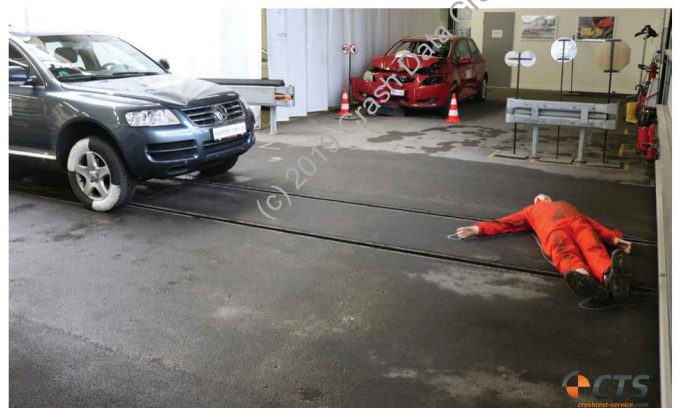
*Figure 13: End positions of the different dummy types*

The end positions of the different dummy types reflect the significant deviation in the movement behaviour. Whilst the biofidelic dummy comes to rest after approximately 18 m almost straight in front of the SUV (Figure 13, right image), the NAMI-dummy rolled off the bonnet to the right during the collision due to the lack of deformation behaviour and reached a longitudinal throwing distance of only 14 m with a lateral offset of 2.5 m from the collision position (Figure 13, left image).

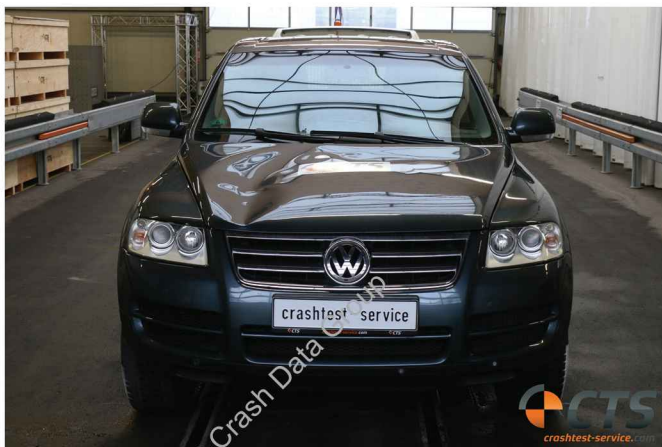
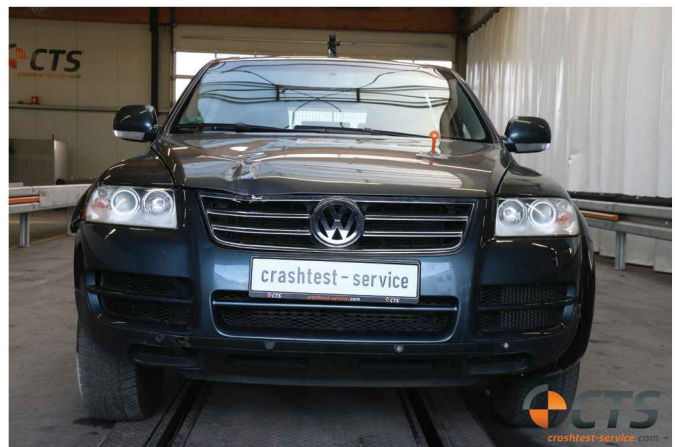
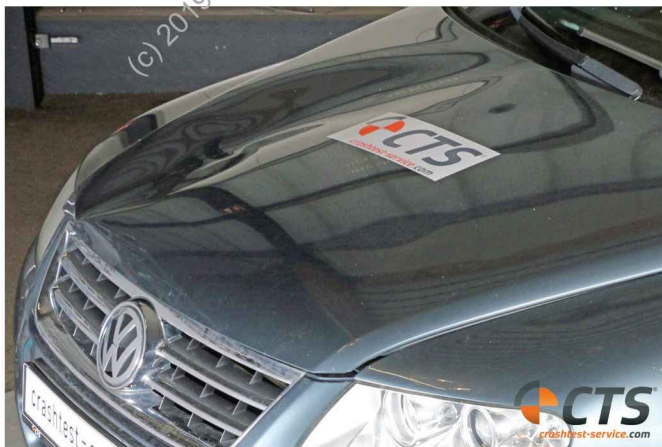
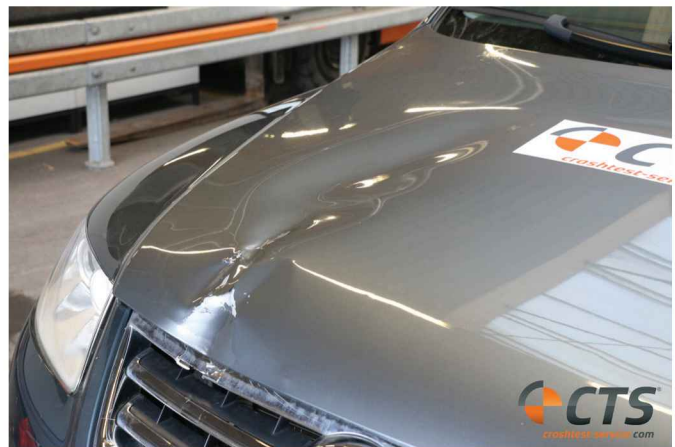
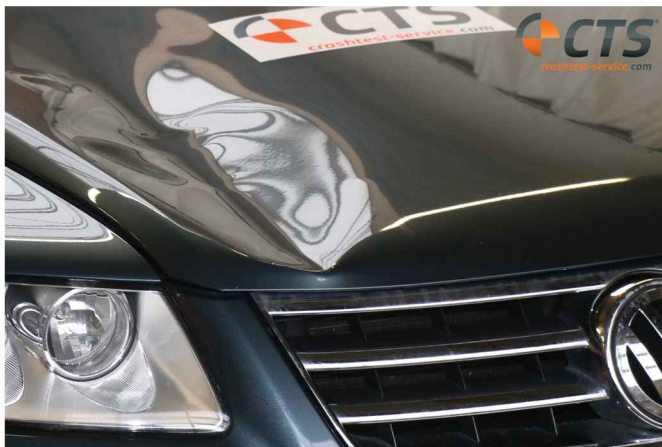
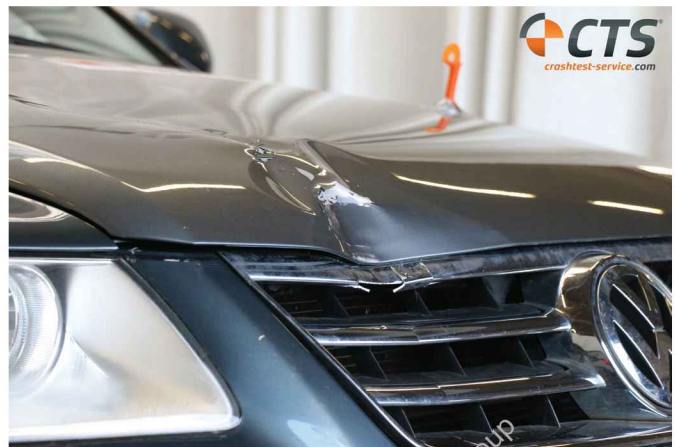
**Figures 14-16: Vehicle damages to the VW Touareg**

The comparison of the vehicle damages on the VW Touareg in both crash tests are shown in Figures 14 to 16. It becomes clear that the SUV during the crash with the biofidelic dummy has a deep extensive indent in the bonnet, which results on the bonnet from the impact of the upper body and the top of the head. The force exchange takes place essentially from the top. At the point of impact with the NAMI-dummy the bonnet was impacted from the front so that the bonnet at the first contact was significantly compressed backwards and the paintwork partially flaked. Additionally, the front grill and the bumper covering underneath the right headlight have been damaged by the impact with the NAMI-dummy, which do not occur when impacting the biofidelic dummy.

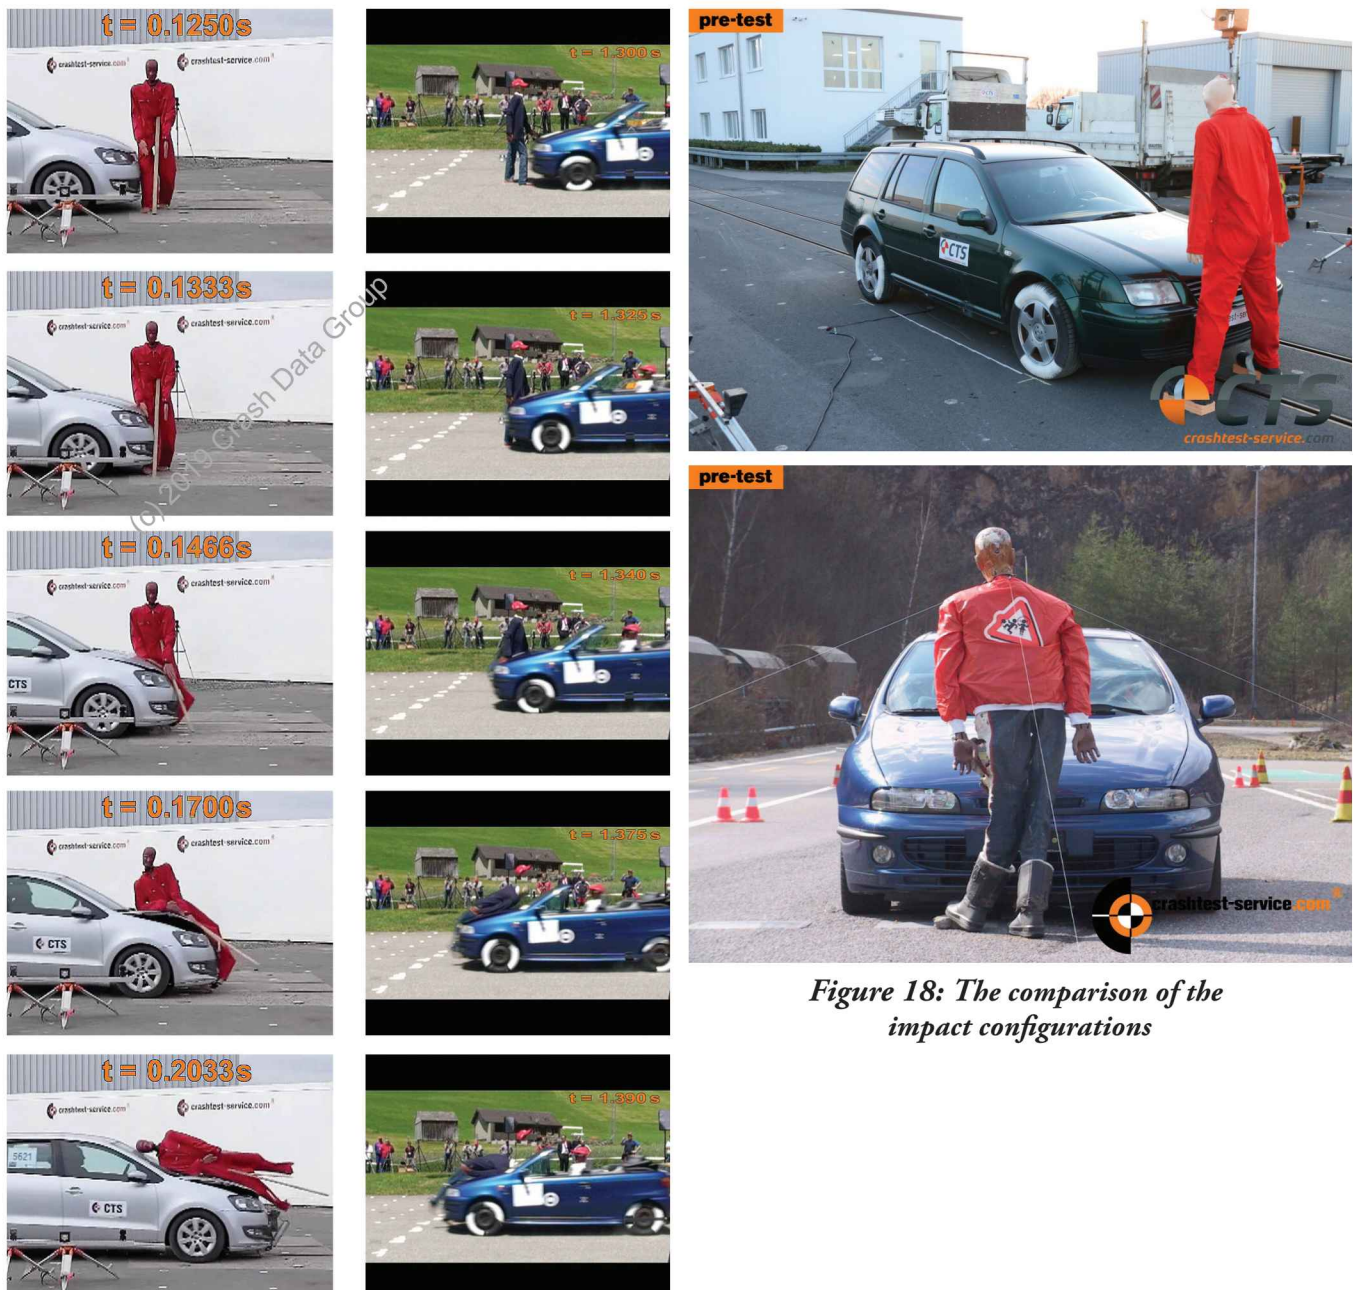
*Figure 18: The comparison of the impact configurations*

*Figure 17: Carrying-characteristic of the pedestrian*

As shown in the comparison in the series of images in Figure 17 the carrying-characteristic of the pedestrian is dependant on the impact direction. A lateral impact impedes the bending movement of the upper body, a head-on impact causes the pedestrian to bend like a folding knife on the vehicles front, the forwards bending of the upper body is unrestrictedly possible.

So far there are only very few crash tests in order to judge the vehicle damages during a head-on impact with a pedestrian. For the purpose of the preparing an accident reconstruction expert report, a crash test at CTS was commissioned, where a biofidelic dummy should be impacted head on at a speed of almost 60 kph. The test vehicle used was a VW Bora. In order to also be able to make a comparison in head-on collisions between a biofidelic and a conventional dummy a crash test with a Fiat Bravo from the CTS-database was also used, where a conventional dummy was impacted head-on at the same velocity. The comparison of the impact configurations is presented in Figure 18.

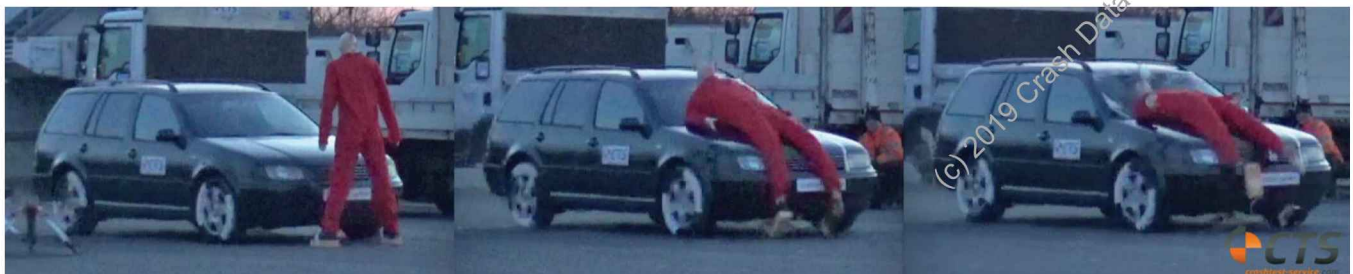
*Figure 19: The movement sequence of the biofidelic dummy in a head-on crash impact configurations*

The movement sequence of the biofidelic dummy in a head-on crash is indicated in Figure 19. The upper body tilts forwards whilst the legs are initially pulled under the car and then thrown back (from the perspective of the pedestrian) by the vehicles front. At the collision speed of the VW Bora at 62 kph the dummy does not hit the bonnet, which is the case when laterally impacted and the collision-related rolling off, but rather hits the front windscreen of the test vehicle directly with the head.

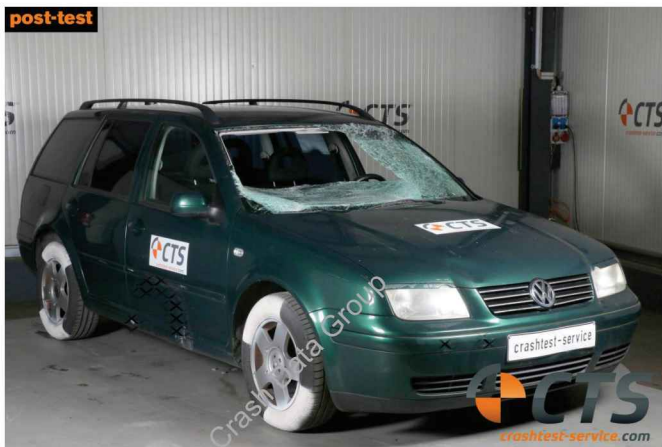
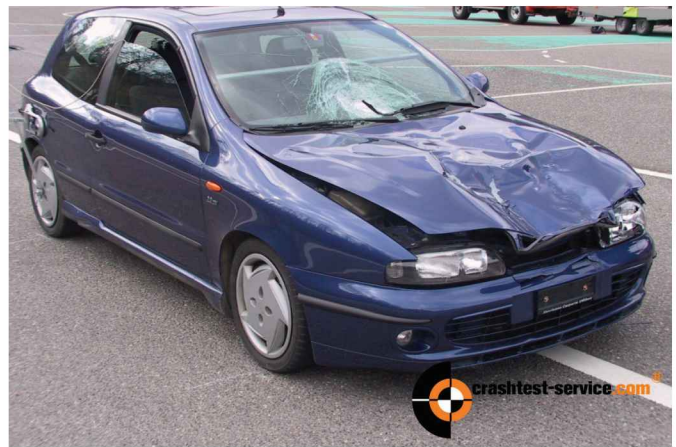
**Figure 20: The comparison of the vehicle damages**

The comparison of the vehicle damages is shown in Figure 20. The bonnet of the Fiat Bravo is severely deformed and raised, since the rigid Winterthur-dummy<sup>1</sup> pushes the bonnet back and inwards at the point of contact. A similar behaviour shown by the NAMI-dummy due to its immobility when laterally impacted by a VW Touareg.

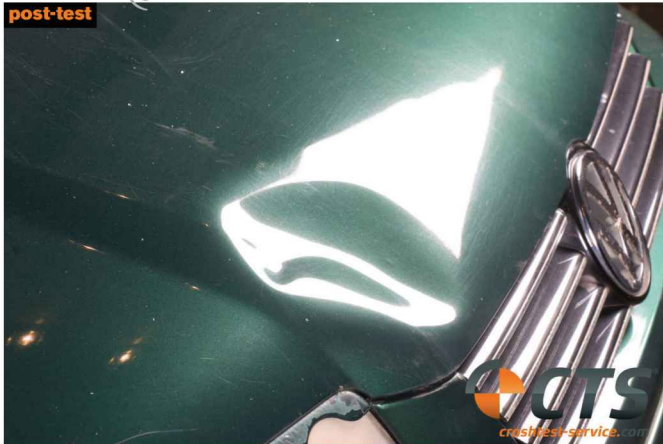
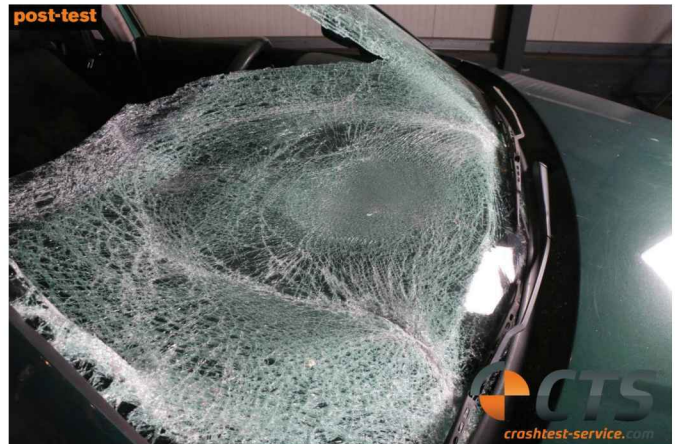
**Figure 21: The bonnet of the VW Bora**

Besides the dent in the front edge of the bonnet which can be attributed to the knee impact of the biofidelic dummy, the bonnet of the VW Bora at the same collision speed was not damaged, Figure 21. The fracture caused by the impact of the head is situated at roughly the same height as on the Fiat Bravo and shows a lower intensity. The fact that the front windscreen of the VW Bora came around two thirds loose from the frame and was pushed inwards it is possible that it is not solely due to the high collision speed of 62 kph. Since the original windscreen of the VW Bora was

slightly cracked before the crash test, it was replaced two days prior to the test. The unusual fracture pattern at the edges of the front windscreen is eventually due to the prior exchanging of the windscreen so that only the damages to the bonnet can be used to compare the crash behaviour of the biofidelic and conventional dummies. The unexpected minimal damages caused to the bonnet of the VW Bora in contrast to the severely deformed bonnet of the Fiat Bravo at the same velocity level rises the question whether in the past the collision speed of the accident vehicle in head-on

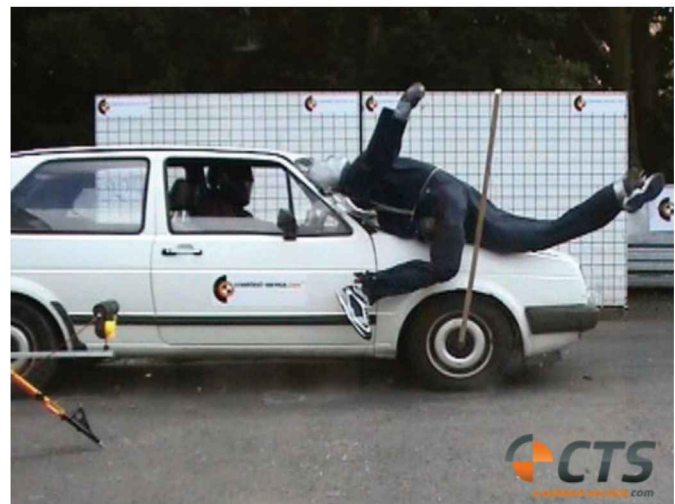
*Figure 22: Collision between Audi Q7 and VW Golf III with a biofidelic dummy*

Figure 22 shows hereby a crash comparison of a biofidelic dummy and a conventional dummy in a grazing impact by which it came to an impact with the head on the front windshield and subsequently a contact with the A-pillar. On the left of Figure 22 shows a collision of an Audi Q7 at 57 kph with a biofidelic dummy. The right image shows a test by which a VW Golf III grazes a Hybrid-I dummy at 62 kph. The damage pattern comparison can be seen in Figure 23, which shows in both tests a significant damage to the front windscreen in the form of a fracture. The damage to the A-pillar fundamentally differentiates due to the vehicles and in particular the movement behaviour of the dummy.

Due to the mobility of the biofidelic dummy it hits the front windshield with the head in a nodding-movement and rolls then, initiated by the previous grazing impulse, over the A-pillar and the wing mirror. Due to the movement and therefore the change in contact points the A-

pillar of the Audi does not appear to be deformed. In a collision with the VW Golf III, the dummy tilts over on to the vehicle. Because of the hard construction, the A-pillar is massively deformed.

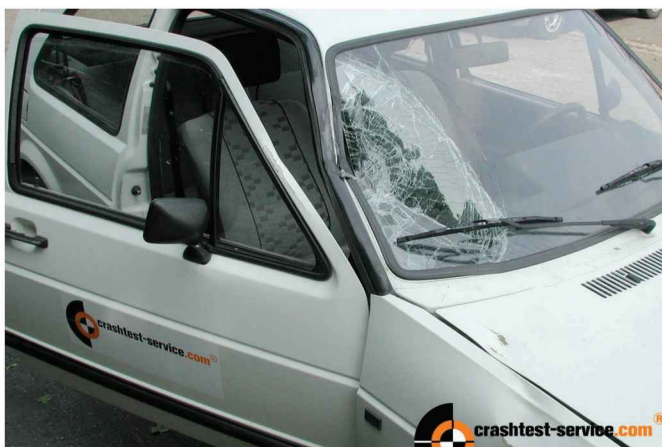
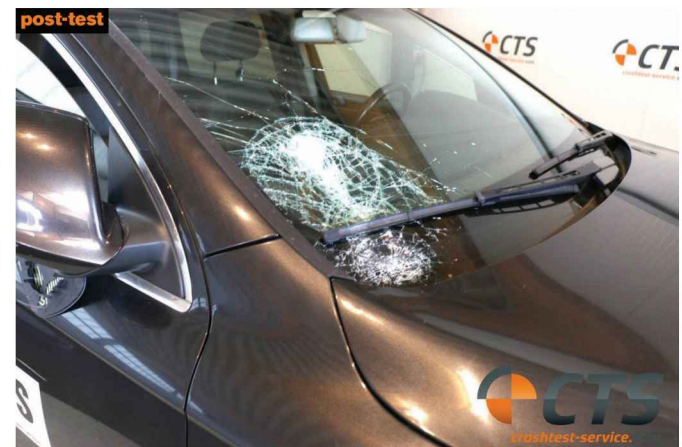
*Figure 23: Damage pattern comparison*

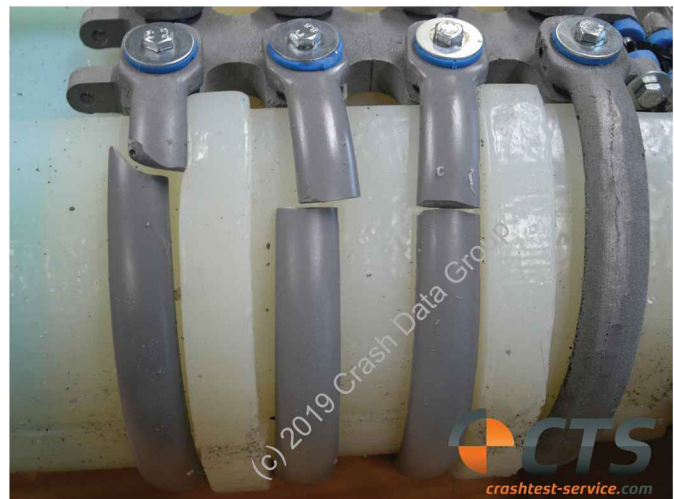
**Figure 25: An autopsy of the biofidelic dummy after a collision**
