# Assessment of injury probability based on crash tests using biofidelic dummies

Dummy-Crashtest Conference

Münster (Germany), September 2021, 30<sup>th</sup>

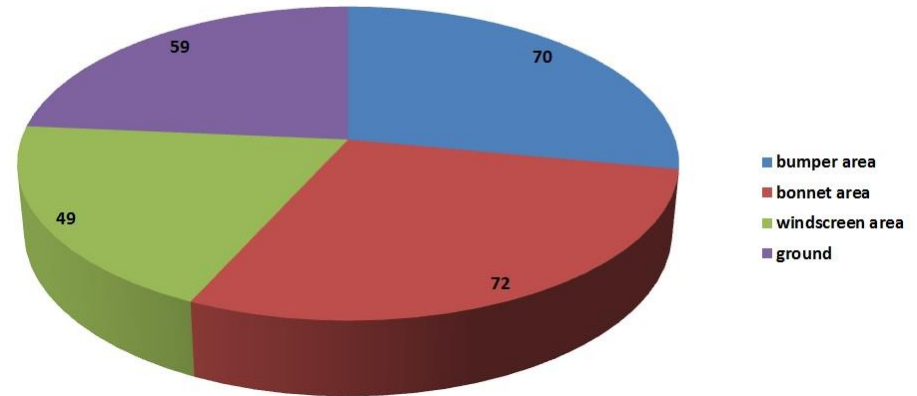
Relationship between front-end area and injuries caused

- 21 real-world accidents have been analysed
- 334 individual injuries
- 250 injuries have been assigned to a single injury-causing vehicle structure or the ground

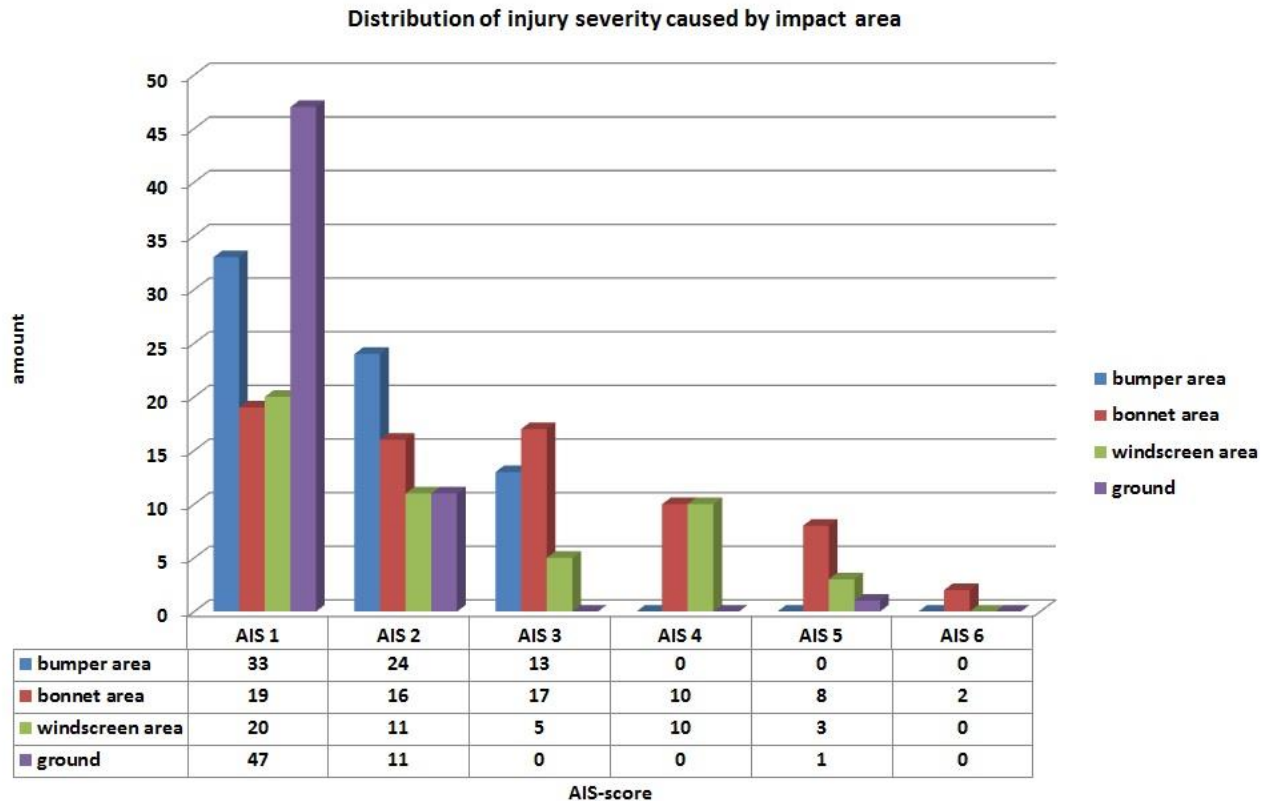
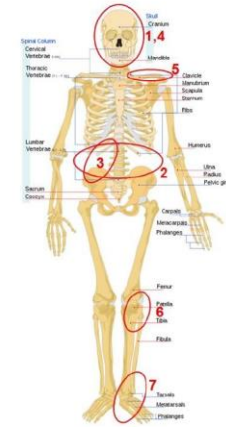
vehicle data	pedestrian data
Opel Astra Caravan F 1994	39 years
trapezium	male
1095 kg	182 cm
60 - 65 km/h	113 kg
pre-crash braking	survived
frontal	
complete

no.	injury	injury caused by hit	injury caused by ...
1	1st degree craniocerebral injury with temporary unconsciousness	primary	roof leading edge
2	blunt abdominal trauma	primary	windscreen
3	liver haematoma	primary	windscreen
4	facial skin abrasion	primary	windscreen
5	fracture of left clavicle	primary	bonnet
6	maisonneuve fracture of left fibula with fracture of left lateral malleolus	primary	bumper
7	medial malleolus haematoma	primary	bumper

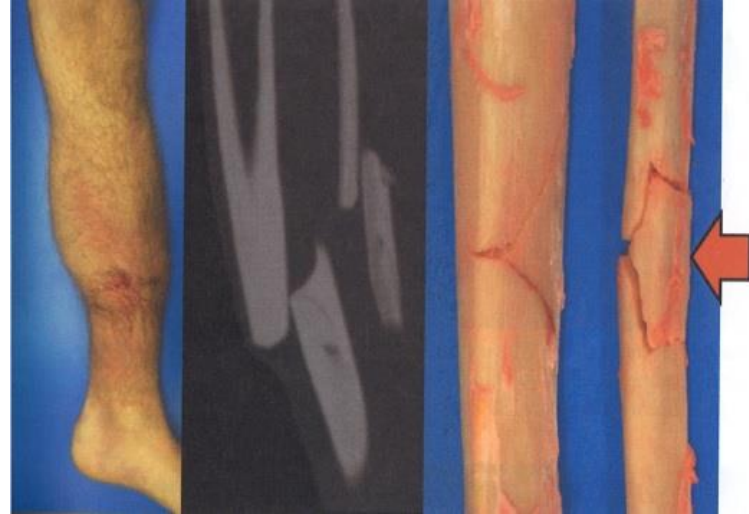
- Messerer's wedge fracture:
  - The apex points in the direction of the vehicle's velocity vector
  - The wedge fracture, however, must not be "used" on its own
  - The wedge fracture must be "corroborated" by relevant soft tissue injuries

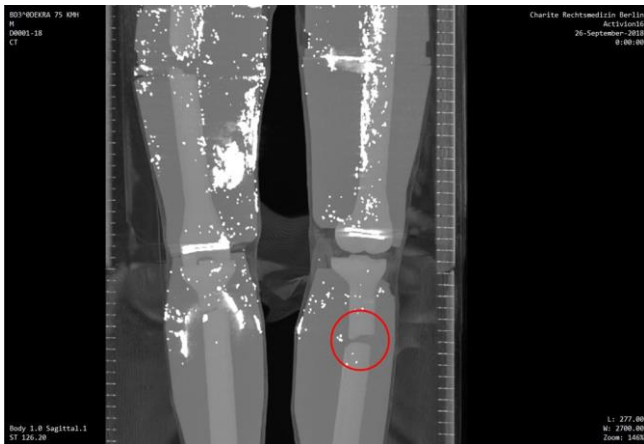
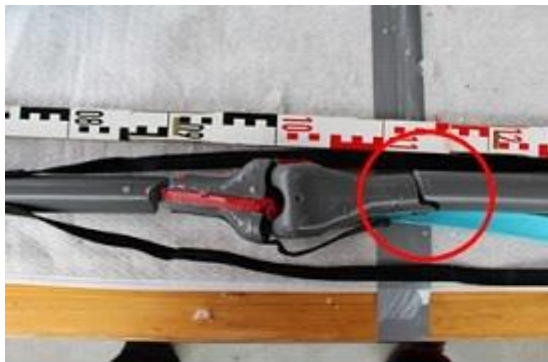
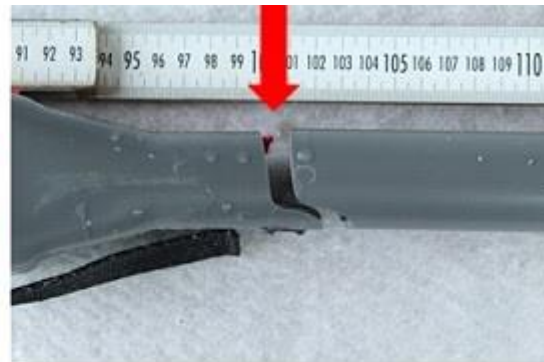
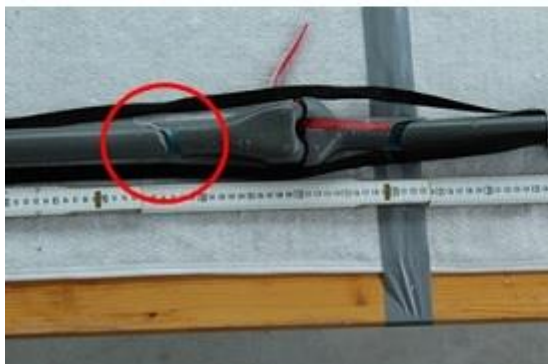
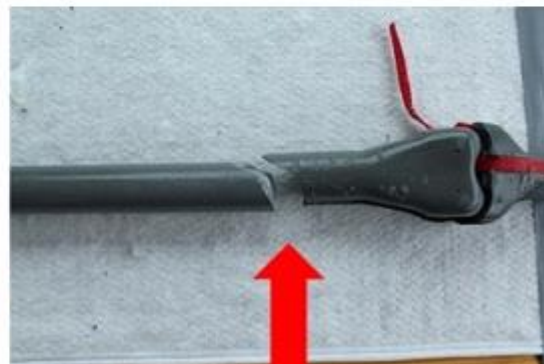
- Messerer's wedge fracture:
  - The protrusion indicates the impact direction

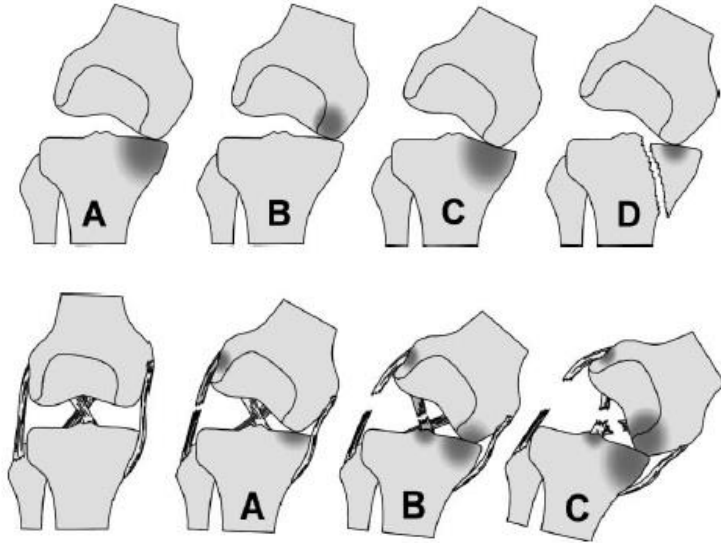
Teresinski, G., & Madro, R. (2001). Knee joint injuries as a reconstructive factors in car-to-pedestrian accidents. *Forensic Science International*, 124, 74-82.

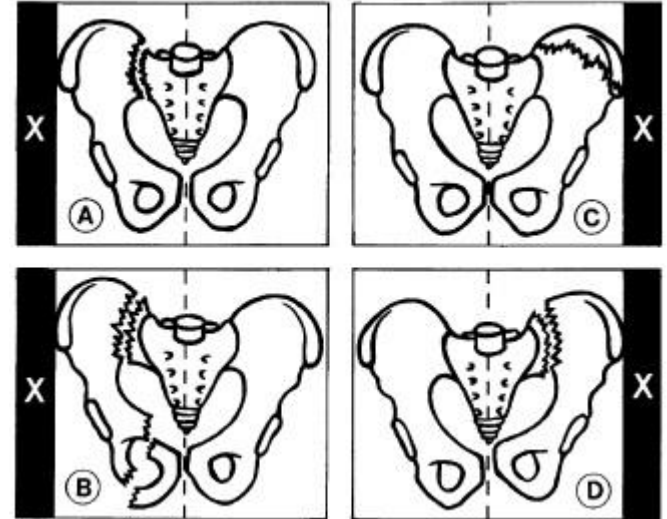
Teresinski, G., & Madro, R. (2001). Pelvis and hip joint injuries as a reconstructive factors in car-to-pedestrian accidents. *Forensic Science International*, 124, 68-73.

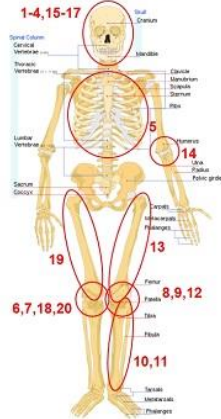
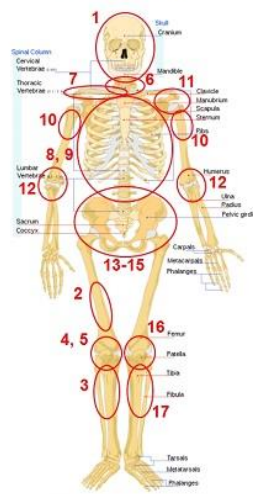
## Pedestrian 1

pedestrian 2	
vehicle data	pedestrian data
BMW 320i 1996	51 years
1300 kg	male
173 cm	173 cm
53 - 63 km/h	83 kg
late or unbraked	deceased
frontal	
complete

no.	injury
1	fracture of left scapula
2	fracture of right fibula
3	fraying of fibres of right knee joint's medial collateral ligament
4	rupture of left knee joint's lateral collateral ligament with opening of articular cavity and bony rupture of lateral collateral ligament
5	multiple rib fractures left: 1st to 6th rib at linea axillaries anterior and 3rd to 8th rib at medial linea scapula
